# PLAY AREA SAFETY INSPECTION REPORT

Olveston Parish Council

03 May 2017

Site Owner : **Olveston Parish Council**  
Site Name : Olveston PC - Olveston Parish Hall  
Date of Inspection : 03 May 2017  
Inspected by : Bill Slater

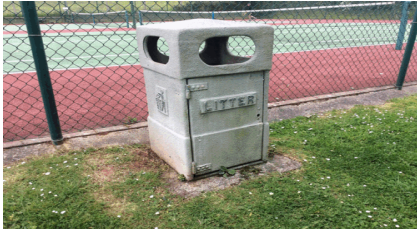
| Facilities | | | | |
|---|---|---|--|--|
| Litter Bin<br><br>Risk Score : 2<br>Risk Level : Very Low | Bins | Satisfactory<br><br> | | |

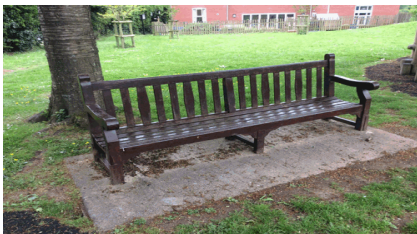
| Facilities | | | | |
|---|---|---|--|--|
| Seating - Bench<br><br>Risk Score : 2<br>Risk Level : Very Low | Seating | Satisfactory<br><br> | | |

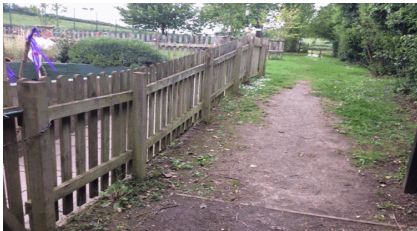
| Facilities | | | | |
|---|---|---|--|--|
| Fencing<br><br>Risk Score : 3<br>Risk Level : Very Low | Fencing | Satisfactory<br><br> | | |

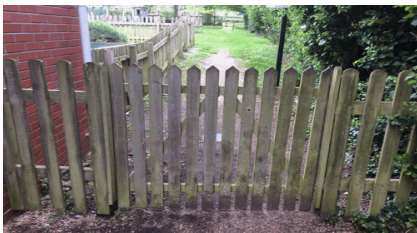
| Facilities | | | | |
|---|---|---|--|--|
| Gate<br><br>Risk Score : 4<br>Risk Level : Low | Entrance | Satisfactory<br><br> | | |

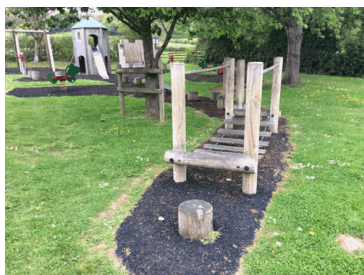
## Agility Trail

Risk Level : Low

Risk Score : 5

| Comments, action or control required | | Risk Level | Risk Score ‡ |
|---|---|---|---|
| <b>Equipment</b> | No remedial maintenance work is required at this time. | | |
| <b>Surfacing - Synthetic Fill</b> | No remedial maintenance work is required at this time. | | |

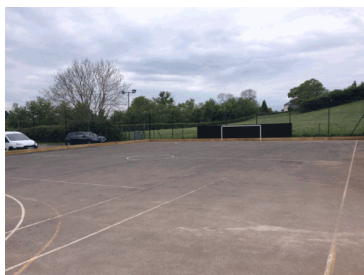
## MUGA

Risk Level : Low

Risk Score : 7

| Comments, action or control required | | Risk Level | Risk Score ‡ |
|---|---|---|---|
| <b>Equipment</b> | No remedial maintenance work is required at this time. | | |
| <b>Surfacing - Tarmac</b> | No remedial maintenance work is required at this time. | | |

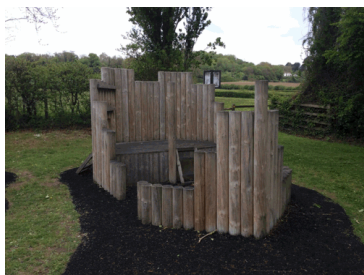
## Play Ship

Risk Level : Very Low

Risk Score : 3

| Comments, action or control required | | Risk Level | Risk Score ‡ |
|---|---|---|---|
| <b>Equipment</b> | No remedial maintenance work is required at this time. | | |
| <b>Surfacing - Synthetic Fill</b> | No remedial maintenance work is required at this time. | | |

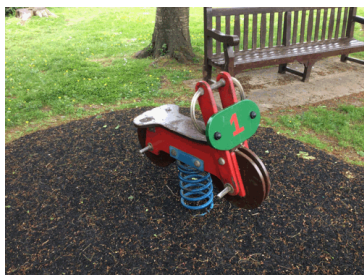
## Rocker - Bike

Risk Level : Very Low  
Risk Score : 3

The item fails to meet the requirement of the relevant standard.

| Comments, action or control required | | Risk Level | Risk Score ‡ |
|---|---|---|---|
| Finding : | Protruding handles/footrests | Low | 4 |
| Finding : | Laminate damaged | Low | 4 |

| Comments, action or control required | | Risk Level | Risk Score ‡ |
|---|---|---|---|
| Task : | Rub down and treat damaged edges | | |

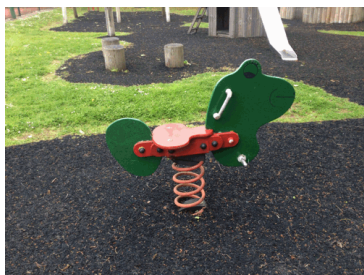
## Rocker A

Risk Level : Very Low

Risk Score : 3

| Comments, action or control required | | Risk Level | Risk Score ‡ |
|---|---|---|---|
| <b>Equipment</b> | No remedial maintenance work is required at this time. | | |
| <b>Surfacing - Synthetic Fill</b> | No remedial maintenance work is required at this time. | | |

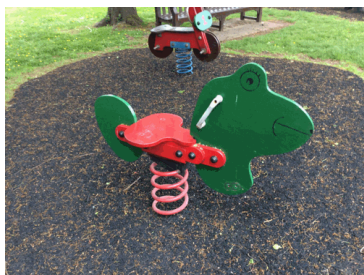
## Rocker B

Risk Level : Very Low  
Risk Score : 3

The item fails to meet the requirement of the relevant standard.

| Recommended Maintenance and Risk Assessment Evaluation: | | Risk Level | Risk Score ‡ |
|---|---|---|---|
| Finding : | Item - Parts Missing | Low | 5 |
| Notes : | Foot rests. | | |

| Recommended Maintenance and Risk Assessment Evaluation: | | Risk Level | Risk Score ‡ |
|---|---|---|---|
| Task : | Replace missing parts | | |

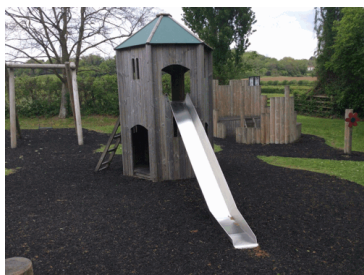
## Slide - Tower

Risk Level : Low  
Risk Score : 6

| Comments, action or control required | | Risk Level | Risk Score ‡ |
|---|---|---|---|
| <b>Equipment</b> | No remedial maintenance work is required at this time. | | |
| <b>Surfacing - Synthetic Fill</b> | No remedial maintenance work is required at this time. | | |

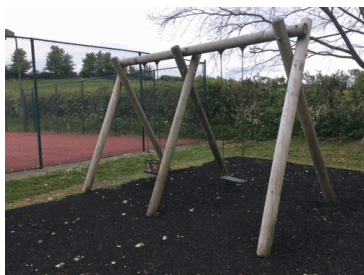
## Swing - Mixed - 2 Bay 1 Junior 1 Toddler Seat

| Recommended Maintenance and Risk Assessment Evaluation | | Risk Level | Risk Score ‡ |
|---|---|---|---|
| Finding : | There is insufficient splay on the swing chains | Low | 4 |
| Finding : | Loose swing seat eye-bolts | | |
| Finding : | Monitor | Medium | 8 |
| Notes : | Sinking - consider comment from contractor. | Medium | 8 |
| The overall risk for this item at the time of inspection:<br>‡ For Risk Score see Report Notes | | Medium | 8 |

| Recommended Maintenance and Risk Assessment Evaluation | | Risk Level | Risk Score ‡ |
|---|---|---|---|
| Task : | Monitor and check on a routine basis | Low | 6 |
| Task : | Tighten connecting nuts | | |
| Task : | Monitor and check on a routine basis | | |

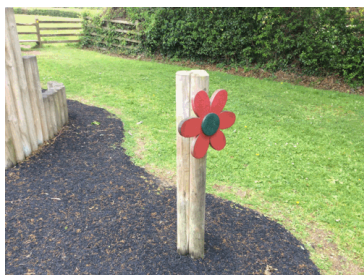
## Talk Tubes

Risk Level : Very Low

Risk Score : 3

| Comments, action or control required | | Risk Level | Risk Score ‡ |
|---|---|---|---|
| <b>Equipment</b> | No remedial maintenance work is required at this time. | | |
| <b>Surfacing - Rubber Mulch</b> | No remedial maintenance work is required at this time. | | |

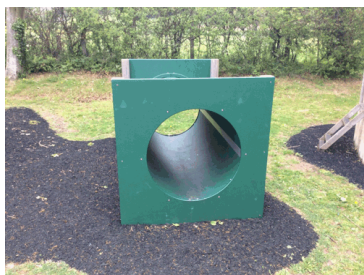
## Tunnel

Risk Level : Low

Risk Score : 4

| Comments, action or control required | | Risk Level | Risk Score ‡ |
|---|---|---|---|
| <b>Equipment</b> | No remedial maintenance work is required at this time. | | |
| <b>Surfacing - Synthetic Fill</b> | No remedial maintenance work is required at this time. | | |
