# Safety Inspection Report

Annual Inspection

## Olveston Parish Hall

30 April 2026

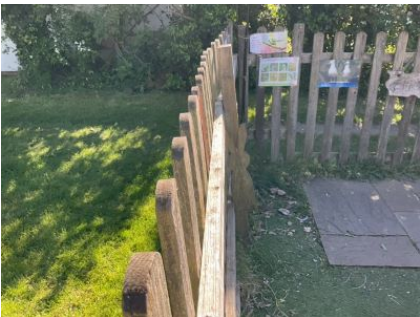
| Description |
|---|
| Loose in ground. |

| Description |
|---|
| Reset. |

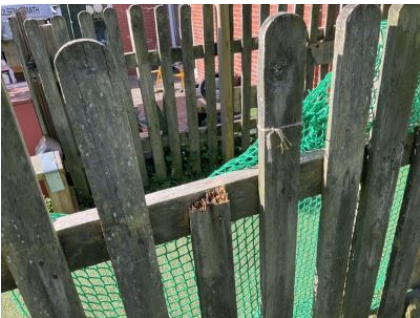
Minor repairs are needed.

Repair.

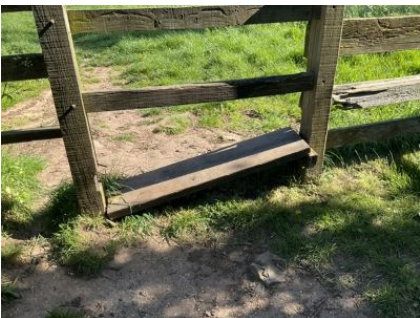
Minor repairs are needed.

Repair.

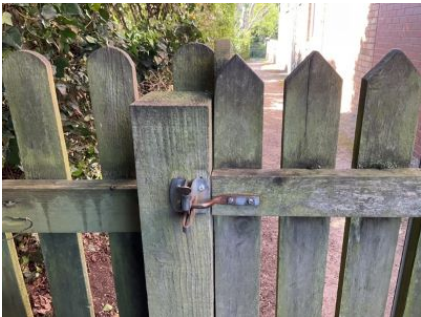
There is a crushing or shearing point on the side of the gate. Where the gaps reduce to less than 12 mm these have been known to cause serious, permanent injury to children, especially on the hinge side where the leverage forces are significant.

Adjust gate / posts / fit new rubber buffer to ensure a spacing of at least 12 mm throughout the range of the gate to remove the entrapment. The 12 mm gap also should apply on the hinge side of the gate.

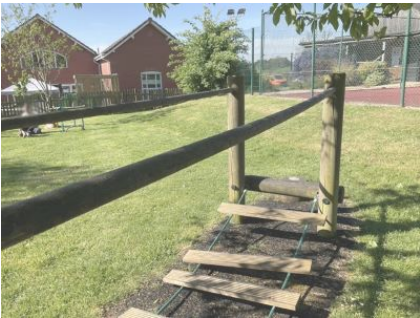
Additional comments are noted below.

The timber hand rails have a lot of flex. Strengthen.

Read the notes for further action.

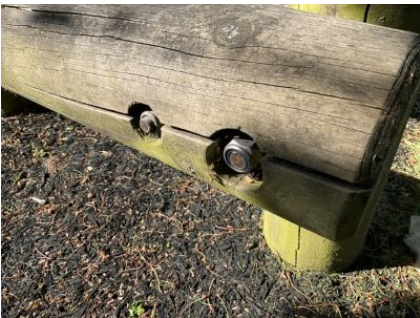
Cap missing.

Replace.

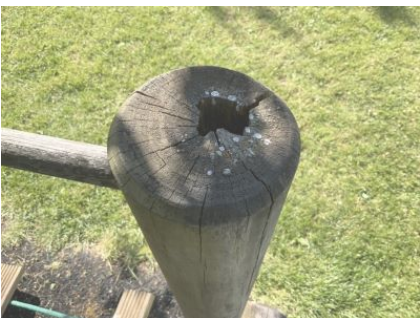
Timber is decayed.

Repair.

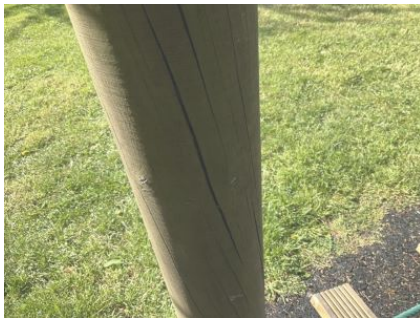
There are natural splits / shakes in the timbers.

Shakes vary. Monitor and consult manufacturer if dimensions exceed 8 mm at sections used to grip / grasp.

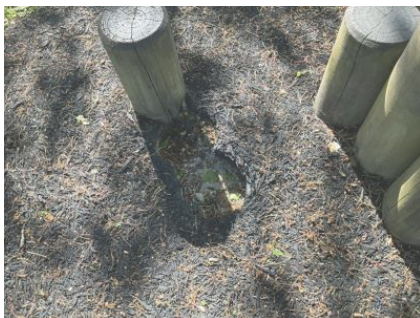
Surface has holes in it.

Repair.

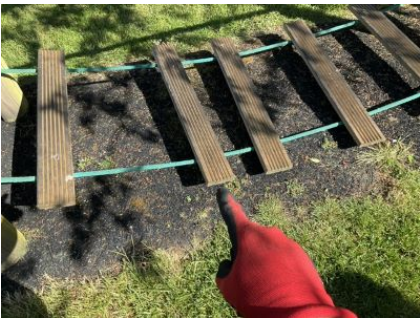
Bolt(s) loose.

Tighten.

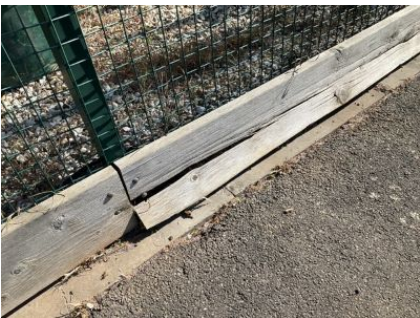
Minor repairs are needed.

Repair.

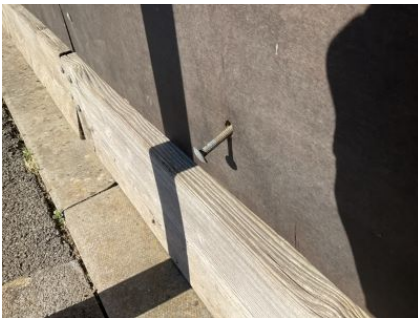
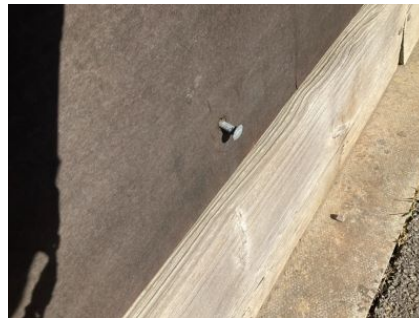
Bolt(s) loose.

Tighten.

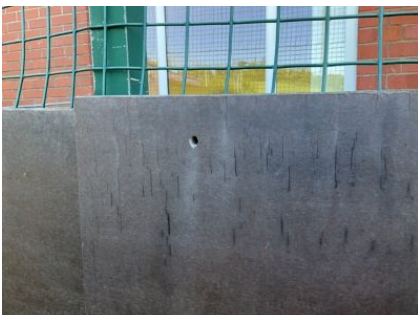
Bolt(s) missing.

Replace missing bolt(s).

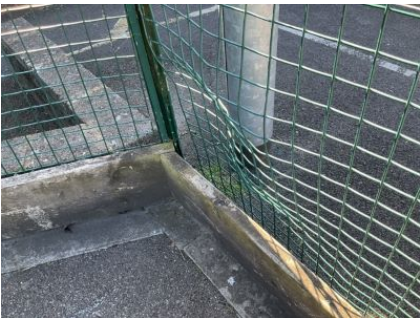
Item is damaged.

Repair.

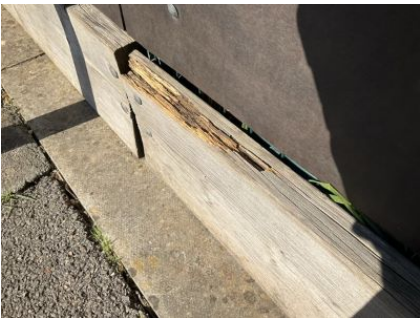
Timber is decayed.

Check on a routine basis.

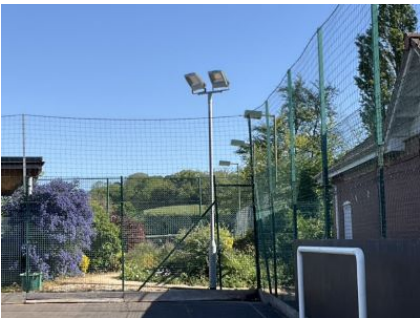
Item was not inspected on this occasion.

Inspection of the floodlights does not form part of this report. Arrange for an inspection of the floodlights by a suitably qualified lighting engineer.

Read the notes for further action.

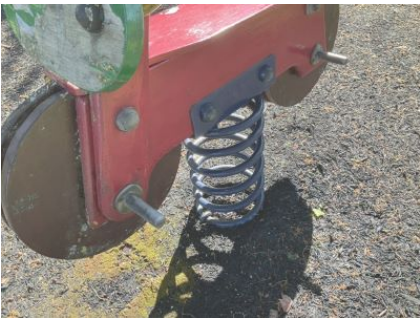
Protruding handles / foot rests.

The unit was installed prior to the publication of the current standards. There is no requirement to make retrospective changes.

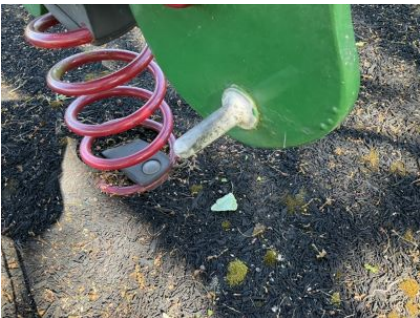
Protruding handles / foot rests.

The unit was installed prior to the publication of the current standards. There is no requirement to make retrospective changes.

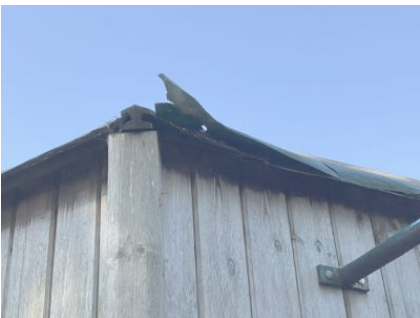
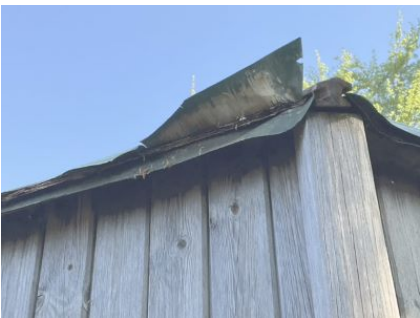
Delamination of wood.

Replace.

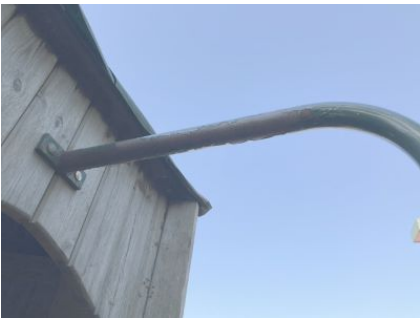
Item has corrosion.

Treat and repair.

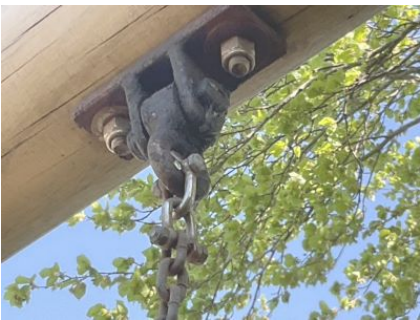
There is wear in the bushes.

Remove shackle bolt and check bush and shackle pin wear, replacing as necessary.

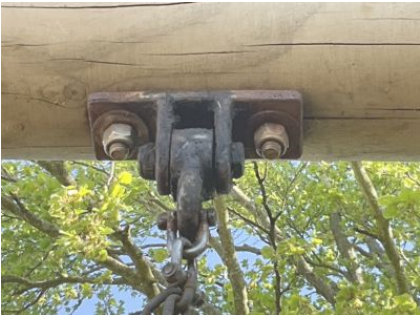
Bolt(s) loose.

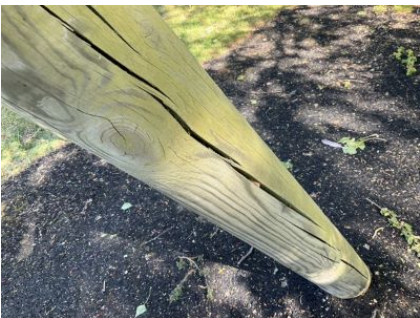
| Description | Tasks | Risk score |
|---|---|---|
| There are natural splits / shakes in the timbers. | DO NOT fill shakes. Monitor and sand back any splintered edges as required. | 3 |

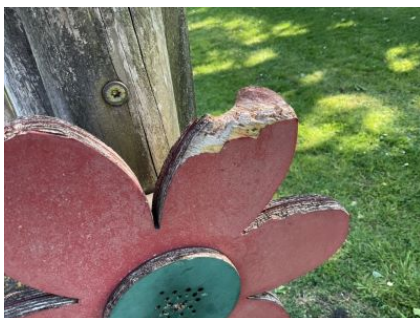
| Description | Tasks | Risk score |
|---|---|---|
| Delamination of wood. | Repair. | 4 |

## Repair.

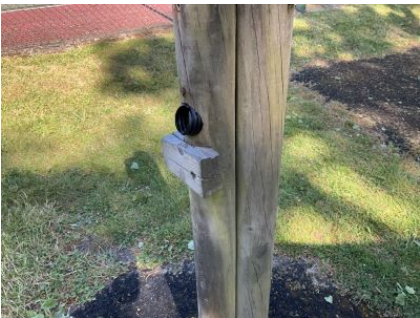
Item has some parts missing.

Replace the missing parts.

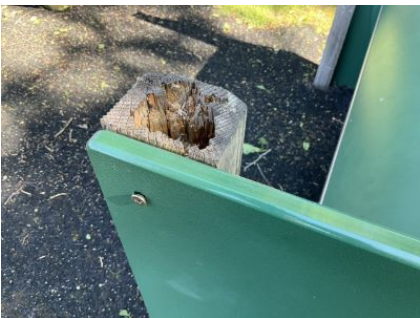
Timber is decayed.

Repair.
