# PLAY AREA SAFETY INSPECTION REPORT

Olveston Parish Council

03 May 2017

Site Owner : **Olveston Parish Council**  
Site Name : Olveston PC - Olveston Parish Hall  
Date of Inspection : 03 May 2017  
Inspected by : Bill Slater

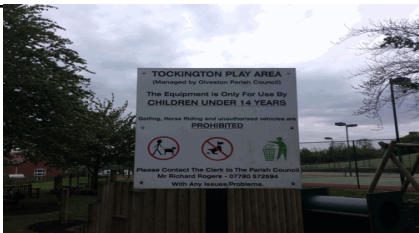
| The Overall Site<br><br>Risk Score :<br>Risk Level : | Site | Finding : The playground is in good condition and appears to be well-maintained<br><br><br>Task : No Action Required | Very Low | 2 | |
